Australian Government
Australian Transport Safety Bureau

Navigation event involving Saab Aircraft Co. 340B, VH-TRX

11 km SW of Williamtown (Newcastle Airport), New South Wales | 8 November 2012

ATSB Transport Safety Report
Aviation Occurrence Investigation
AO-2012-153
Final – 13 March 2015

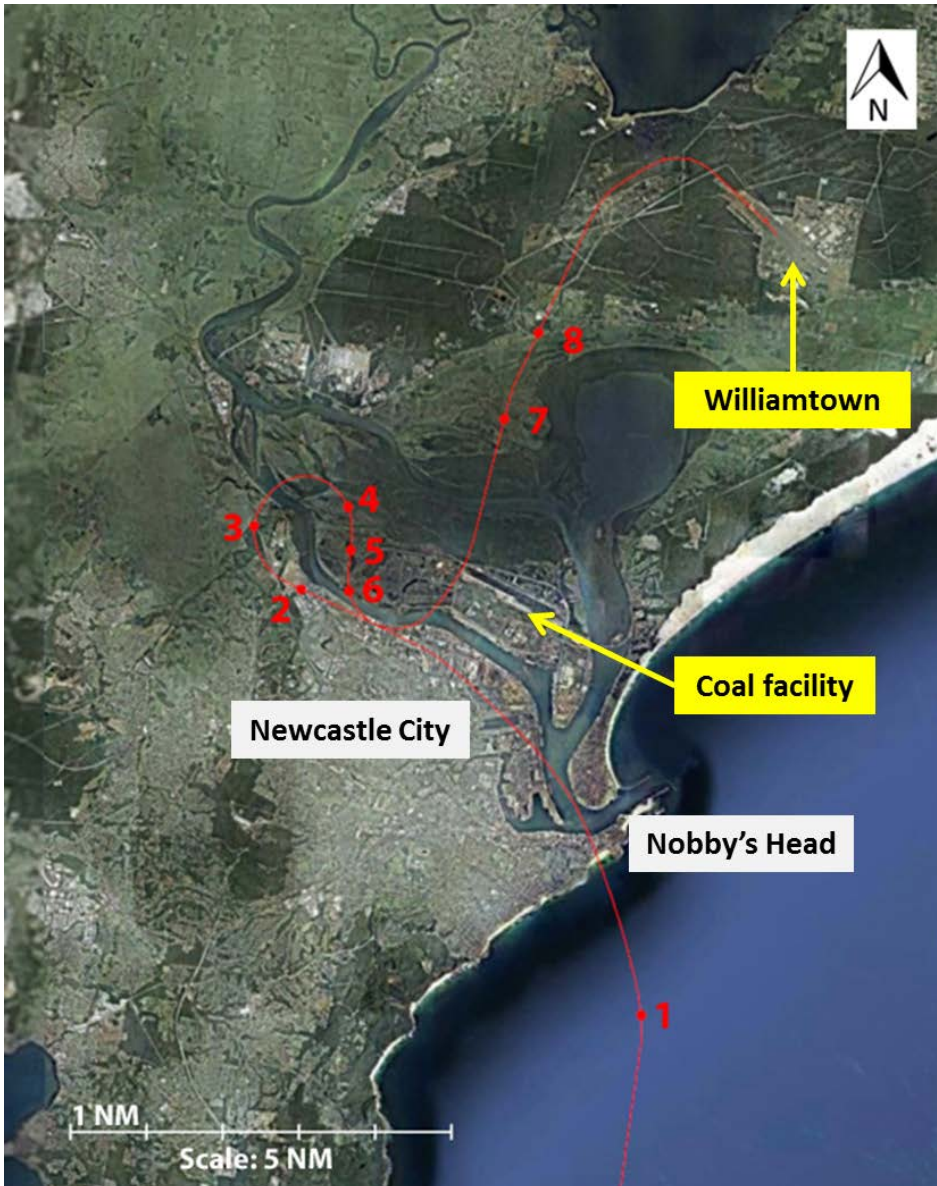
Figure 1: Flight path of VH-TRX¹³

At about 1929, the crew contacted the tower controller. The approach controller continued to monitor the aircraft on the air situation display (radar) after its transfer to the tower controller. The aircraft was observed on radar by both controllers to turn left after passing Nobby's Head and track along the Hunter River on descent (Figure 1).

| 1. | 1929:12 | 10 NM (19 km) south of Williamtown. |
| 2. | 1931:21 | TRX descends from 1,500 ft. |
| 3. | 1931:45 | Tower controller asks the crew of TRX if they were still visual. |
| 4. | 1932:30 | Tower controller advises the crew that they were 6 NM (11 km) south-west of Williamtown; the crew requested radar assistance. |
| 5. | 1932:42 | TRX at 680 ft. (Initial heading guidance from the tower controller at 1932:45). |
| 6. | 1932:55 | Tower controller advises the crew to climb the aircraft. |
| 7. | 1934:30 | Crew requests further guidance from the tower controller (TRX was about 800 ft at this time). |
| 8. | 1934:54 | Crew advises that they have runway 12 in sight. |

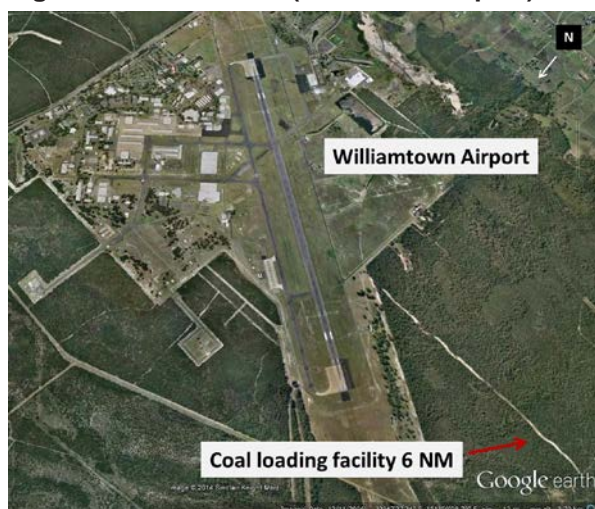
Figure 2: Williamtown (Newcastle Airport)

The single runway at Williamstown, runway 12/30, was aligned south-east to north-west and was 2,438 m in length (Figure 2). The military base and associated infrastructure was situated on the north-east side of the runway, with a smaller civilian apron and terminal on the south-west side. There was an operational requirement for right circuits to runway 12.

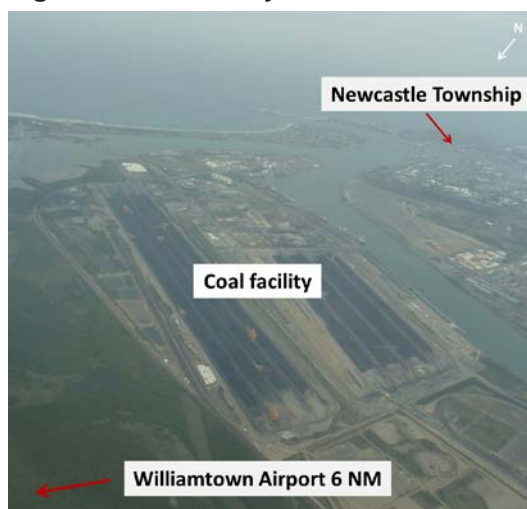
Figure 3: Coal facility

The Kooragang Island coal loading and storage facility was located about 6 NM (11 km) south-west of Williamtown, between the northern and southern branches of the Hunter River and just north of the city. The facility comprised of long lines of coal aligned in a south-south-westerly direction and associated infrastructure (Figure 3), including numerous buildings and lighting, which was similar to that found in an airport environment.

- In the low light conditions and using the visual cues available, the captain incorrectly identified a coal loading and storage facility as the airport environment and manoeuvred the aircraft for an approach to that location.

In addition, shortly after the occurrence, a notice to aircrew was issued that alerted crews to the possibility of misidentifying the Kooragang Island coal loading facility with Williamtown runway 12/30, and the importance of using navigation aids to verify their position when in the vicinity of Williamtown. The notice further stipulated that all approaches into Williamtown were to be via the published runway approach and that visual approaches were not to be conducted, regardless of the weather conditions. This information was incorporated into the company Route Manual for Williamtown and included a diagram showing the proximity of the coal loading facility to the airport. The Route Manual further stipulated that no visual approaches were to be authorised unless emergency or safety circumstances dictated.
