**STATE CORONER'S COURT  
OF NEW SOUTH WALES**

| <b>Inquest:</b> | Inquest into the death of Tyrone Marley Gilks |
| <b>Catchwords:</b> | CORONIAL LAW – Cause and manner of death; motorcycle long distance jumping; risk management; responsibilities of land-holder, local authority; NSW Sport and Recreation |

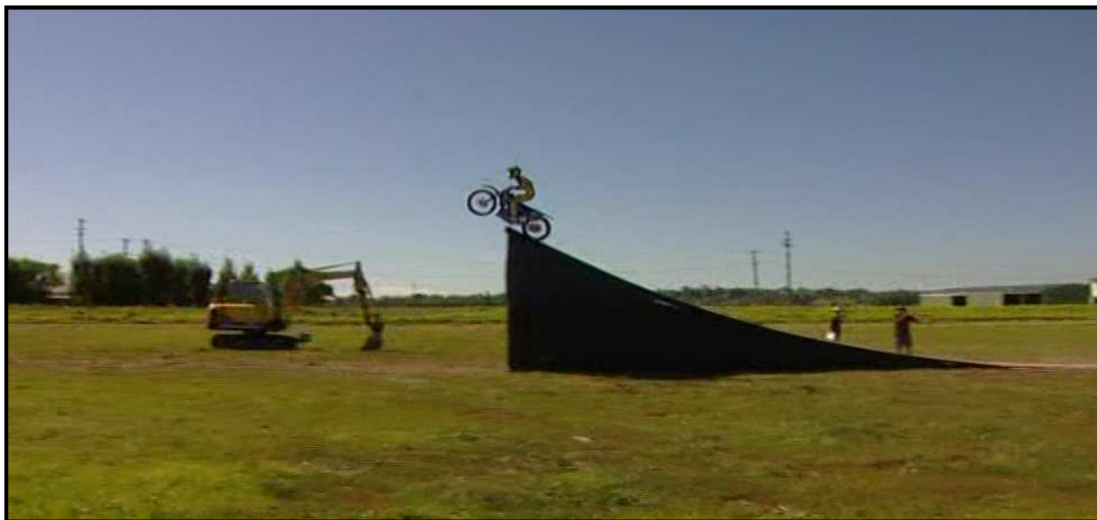
A take-off ramp that Mr Gilks had designed and had built some seven years before the fatality was erected in the arena on the area surrounded by the trotting track. Tyrone had used it on numerous previous occasions. It was about 3.6 metres high, 1.2 wide and 13.65 metres long and it launched the motorbike into the air at about a 28 degree trajectory. It was designed by consulting engineers. The picture below shows Tyrone riding over the ramp.

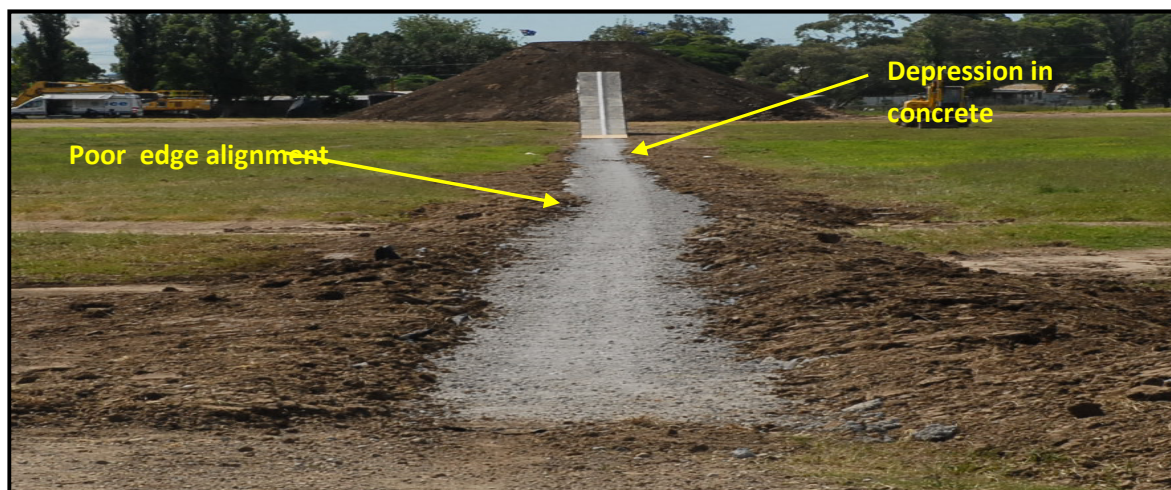
On Monday the 18 March 2013, he commenced to conduct practice runs and jumps at the arena. During these runs it was determined that the grass surface inside the trotting track on the lead up to the take-off ramp was not providing sufficient traction and this would hinder the attainment of the necessary speed. It was decided that it would be necessary to pour a concrete strip to overcome this. On Tuesday the 19 March 2013, this was done. It ran from where the path of the approach left the sealed road to the base of the take off ramp. It was 1.2 metres wide and 130 metres long. This concrete surface was quite rough, it had undulations, and it was not screeded and had a poor alignment. It is pictured below.

- c. The latter portion of the in-run was constructed of a poorly aligned, thin, rough and inconsistent un-screeded concrete strip which was clearly an afterthought and was prepared with poor execution.
