# Lake Macquarie City Council

## State of the Beaches 2012–2013

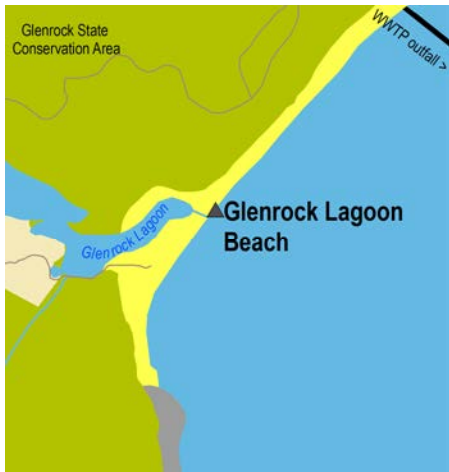
# Glenrock Lagoon Beach

Glenrock Lagoon Beach is 300 metres long and is located toward the southern end of Burwood Beach. The beach is backed by Glenrock State Conservation Area.

The Beach Suitability Grade of Good indicates that the microbial water quality is considered suitable for swimming most of the time but the water may be susceptible to pollution from a few potential sources of faecal contamination.

The response to rainfall graph indicates that enterococci levels increased slightly with increasing rainfall, occasionally exceeding the safe swimming limit in response to 10 mm of rainfall.

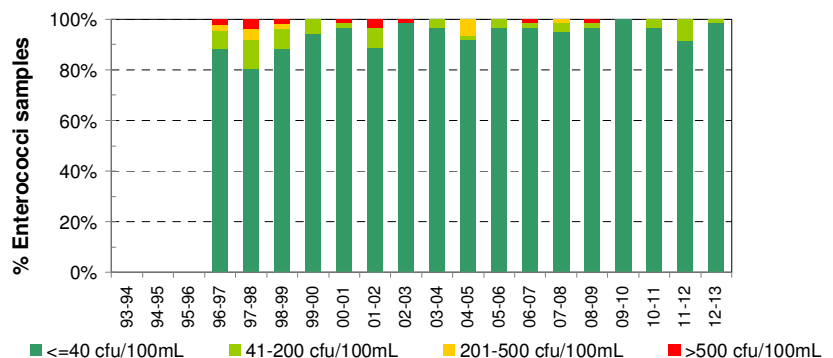
## Trends in enterococci data through time

The site has been monitored since 1996 and microbial water quality has generally been of a high standard.

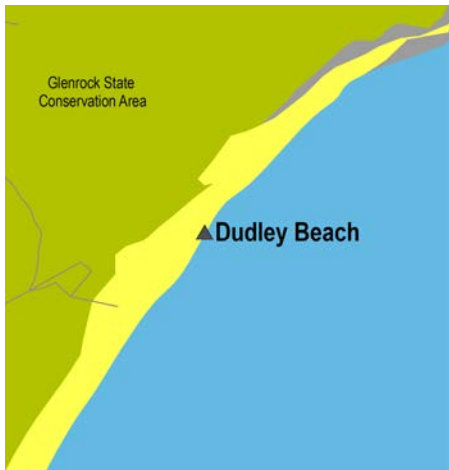
# Dudley Beach

Dudley Beach is one kilometre long. It is in the Glenrock State Conservation Area and is backed by bushland.

The Beach Suitability Grade of Very Good indicates that the microbial water quality is considered suitable for swimming almost all of the time, with few potential sources of faecal contamination.

The response to rainfall graph indicates that enterococci levels increased slightly with increasing rainfall but generally remained below the safe swimming limit across all rainfall categories.

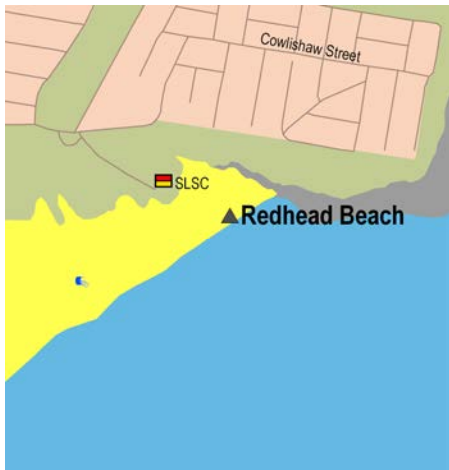
# Redhead Beach

Redhead Beach is located at the northern end of a ten kilometre stretch of beach and is backed by extensive sand dunes and a grassy reserve.

The Beach Suitability Grade of Good indicates that the water quality is safe for swimming most of the time, with several potential sources of minor faecal contamination.

The response to rainfall graph indicates that enterococci levels increased slightly with increasing rainfall but generally remained below the safe swimming limit across all rainfall categories.

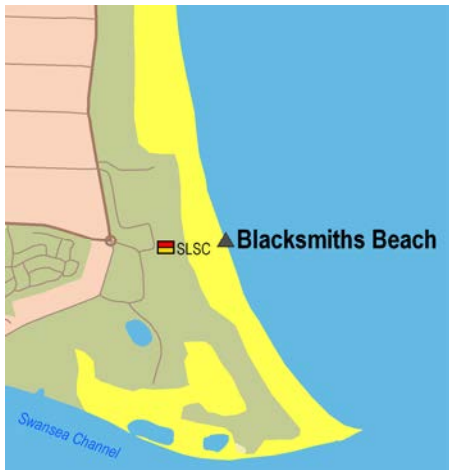
# Blacksmiths Beach

Blacksmiths Beach is toward the southern end of a ten kilometre stretch of beach. A sea wall along the southern end protects the beach from outflow from Lake Macquarie.

The Beach Suitability Grade of Very Good indicates that the microbial water quality is considered suitable for swimming almost all of the time, with few significant sources of faecal contamination.

The response to rainfall graph indicates that enterococci levels increased with increasing rainfall, occasionally exceeding the safe swimming limit in response to 20 mm of rainfall.

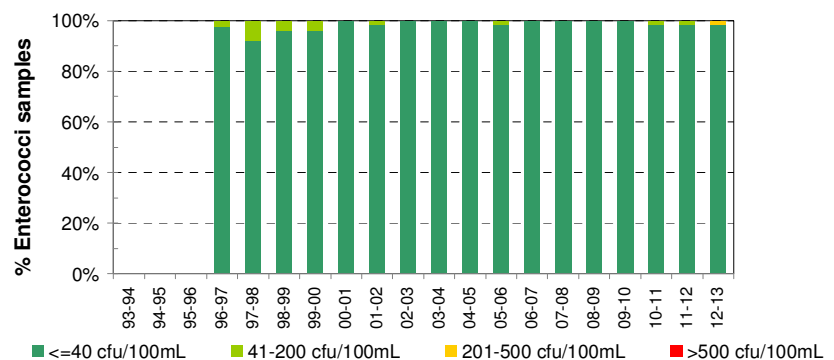
## Trends in enterococci data through time

The site has been monitored since 1996 and microbial water quality has been of a consistently very high standard.

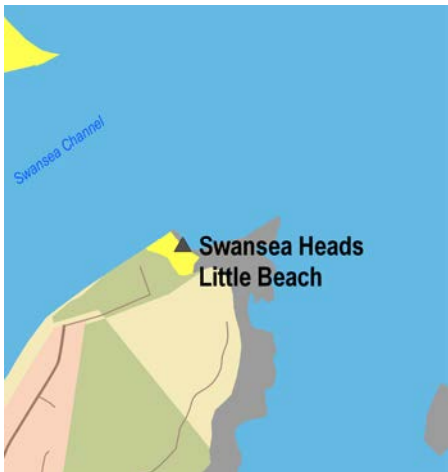
# Swansea Heads Little Beach Beach Suitability Grade: **Good**

Swansea Heads Little Beach is 60 metres long and is directly south-east of the entrance to Lake Macquarie. It is bounded by a small sea wall to the north-west and by a rock platform backed by steep vegetated bluffs to the south-east.

The Beach Suitability Grade of Good indicates that the microbial water quality is generally suitable for swimming but the water may be susceptible to pollution from the outflow from Lake Macquarie.

The response to rainfall graph indicates that enterococci levels had little response to rainfall, occasionally exceeding the safe swimming limit across all rainfall categories.

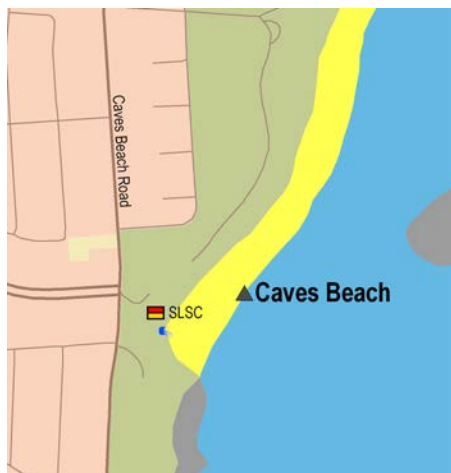
# Caves Beach

Caves Beach is located at the southern end of a 1.8 kilometre beach that runs south from Swansea Heads.

The Beach Suitability Grade of Very Good indicates that the microbial water quality is considered suitable for swimming almost all of the time, with few potential sources of faecal contamination.

The response to rainfall graph indicates that enterococci levels increased slightly with increasing rainfall, but generally remained below the safe swimming limit across all rainfall categories.

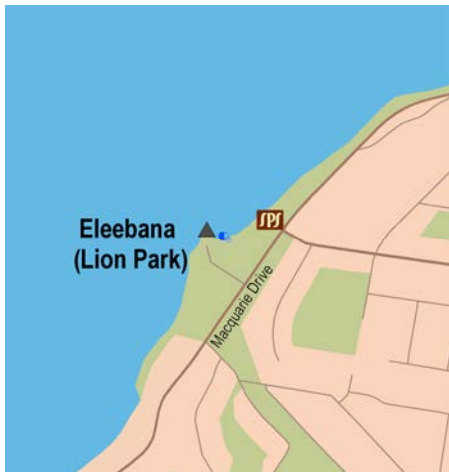
# Eleebana (Lions Park)

Eleebana is located at the northern end of Lake Macquarie in Warners Bay. The adjacent foreshore reserve has toilet and picnic facilities.

The Beach Suitability Grade of Poor indicates that the water quality is susceptible to faecal pollution, particularly after rainfall and occasionally during dry weather conditions, with several potential sources of faecal contamination.

Elevated levels of enterococci were recorded at Eleebana (Lions Park) during both dry and wet weather conditions. Swimming at this site should be avoided due to the unpredictable nature of the contamination.

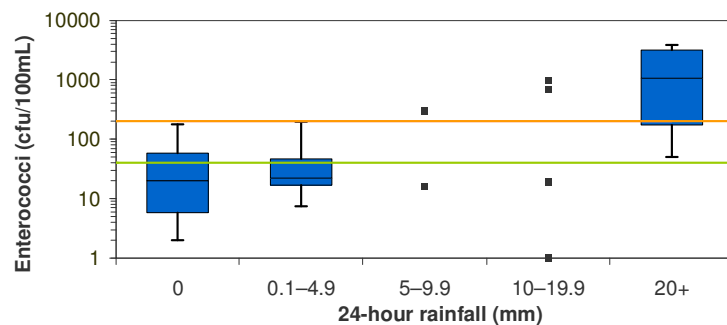
## Response to rainfall

The response to rainfall graph indicates that enterococci levels increased with increasing rainfall, often exceeding the safe swimming limit in response to little or no rain.

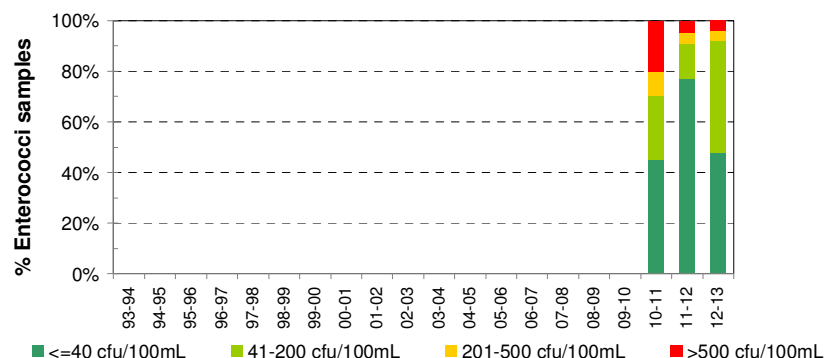
## Trends in enterococci data through time

The site has been monitored since 2010, with elevated levels of enterococci recorded in up to 30 per cent of samples in 2010–2011.

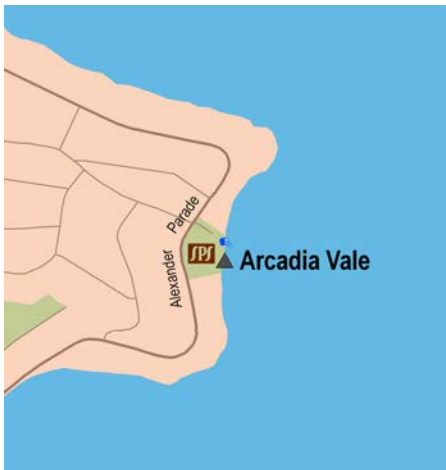
# Arcadia Vale

Arcadia Vale is situated on the western side of Lake Macquarie. There is a playground, toilets and picnic tables in the adjacent park.

The Beach Suitability Grade of Good indicates that the microbial water quality is considered suitable for swimming most of the time but the water may be susceptible to pollution from a few potential sources of faecal contamination.

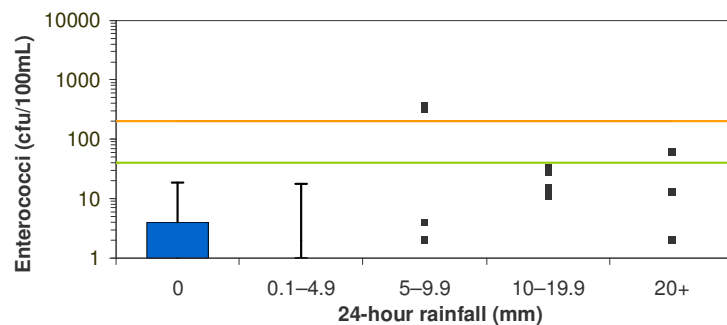
## Response to rainfall

The response to rainfall graph indicates that enterococci levels increased slightly with increasing rainfall, but mostly remained below the safe swimming limit.

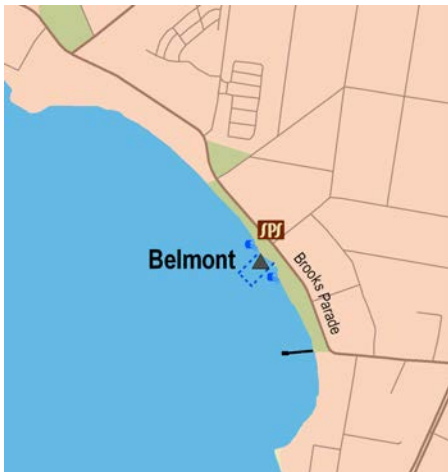
# Belmont

Belmont is located on the eastern side of Lake Macquarie. Access to the sample site is from Belmont Lions Park along Brooks Parade, Belmont. The sample is collected at the baths, from the jetty. The site is adjacent to toilet facilities and residential and commercial properties.

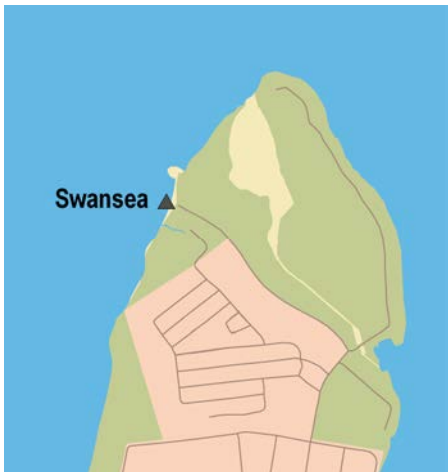
# Swansea

Swansea is on the eastern edge of Lake Macquarie near Swansea Channel and Lakes Entrance. A caravan park is located nearby with a small creek discharging close to the site.

The Beach Suitability Grade of Poor indicates that the water quality is susceptible to faecal pollution, with several potential sources of faecal contamination.

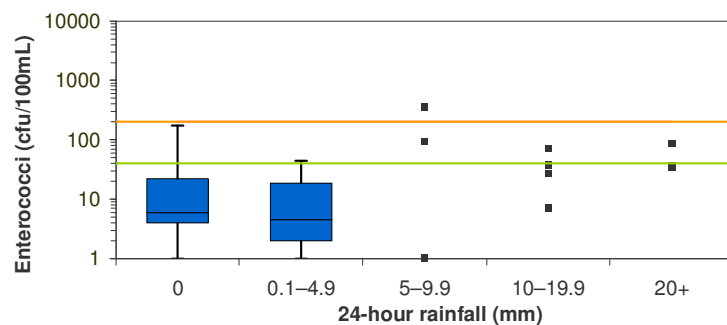
## Response to rainfall

The response to rainfall graph indicates that enterococci levels generally increased slightly with increasing rainfall, occasionally exceeding the safe swimming limit across all rainfall categories.

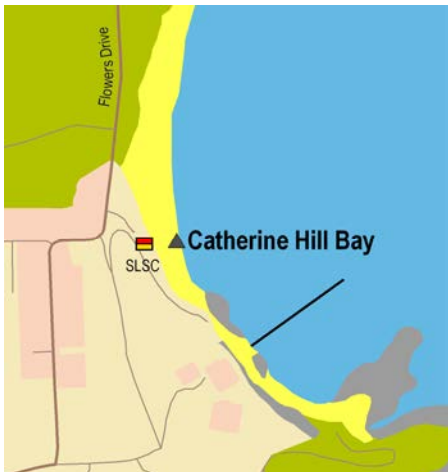
# Catherine Hill Bay

Catherine Hill Bay is at the southern end of a two kilometre stretch of ocean beach. The beach is patrolled by council lifeguards from September to April.

The Beach Suitability Grade of Very Good indicates that the microbial water quality is considered suitable for swimming almost all of the time, with few significant sources of faecal contamination.

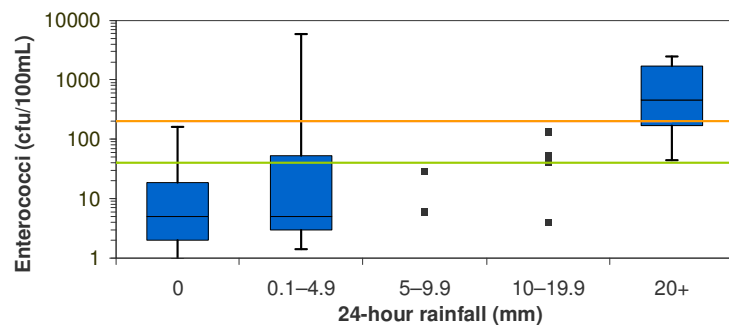
## Response to rainfall

The response to rainfall graph indicates that enterococci levels increased with increasing rainfall, and often exceeded the safe swimming limit after small amounts of rainfall.

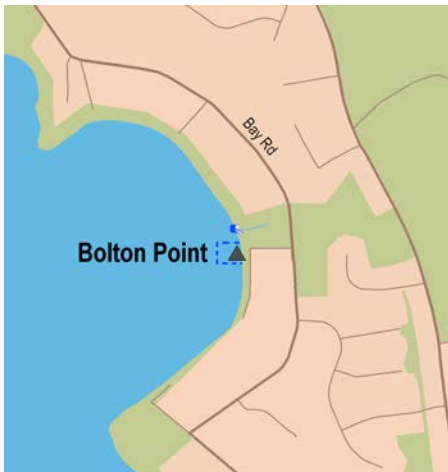
# Bolton Point

Bolton Point is a netted swimming enclosure on the north-western side of Lake Macquarie. There is a foreshore and car park in the immediate vicinity of the baths.

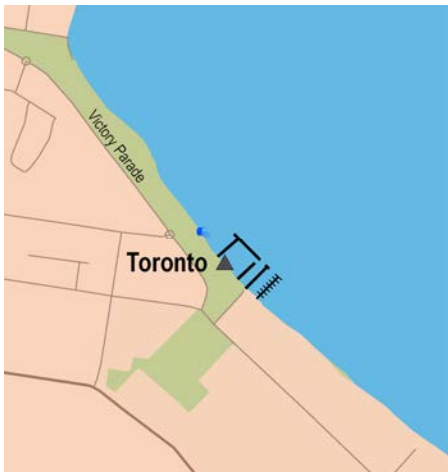
# Toronto

Toronto is a netted swimming enclosure on the western side of Lake Macquarie. The sample is collected near the jetty at the baths.

The Beach Suitability Grade of Good indicates that the microbial water quality is considered suitable for swimming most of the time but the water may be susceptible to pollution from several potential sources of faecal contamination, including stormwater from a nearby drain.

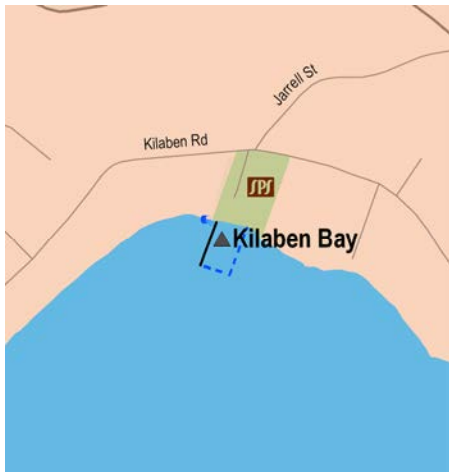
# Kilaben Bay

Kilaben Bay is located on the western side of Lake Macquarie. The sample is collected from the baths which are adjacent to Kilaben Park.

The Beach Suitability Grade of Poor indicates that the water quality is susceptible to faecal pollution from several potential sources of faecal contamination, including stormwater.

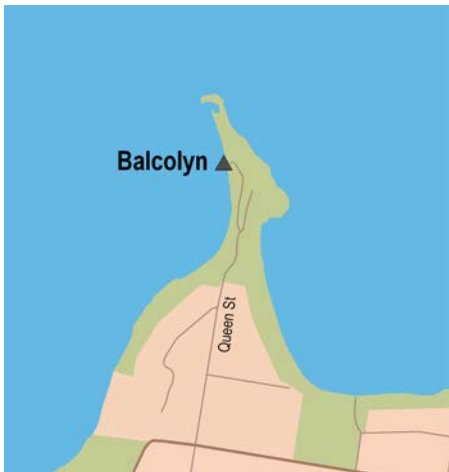
# Balcolyn

Balcolyn is on the western side of Lake Macquarie. The sample is collected from the boat ramp.

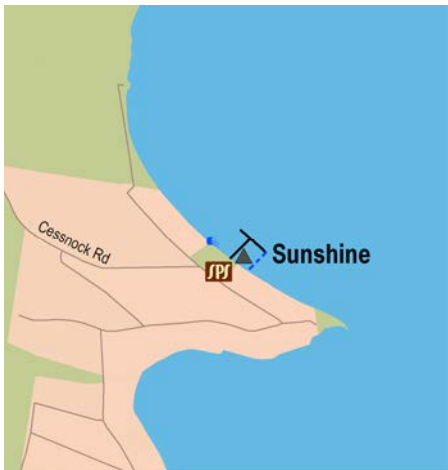
# Sunshine

Sunshine is a netted swimming enclosure on the western side of Lake Macquarie. There are toilet facilities close to the site.
