# City of Newcastle Council

## State of the Beaches 2012–2013

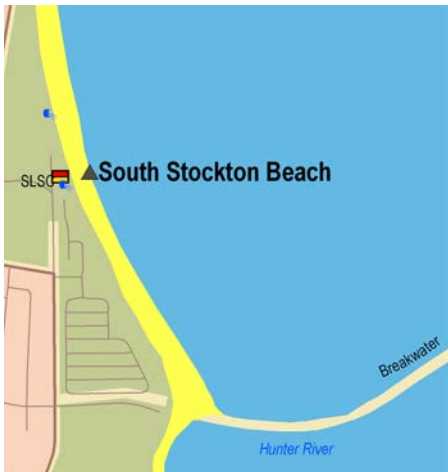
See 'How to read this report' for key to map

South Stockton Beach is toward the southern end of a 32 kilometre stretch of beach that extends north to Birubi Point. Beach conditions are generally safe and lifeguards patrol the beach year round.

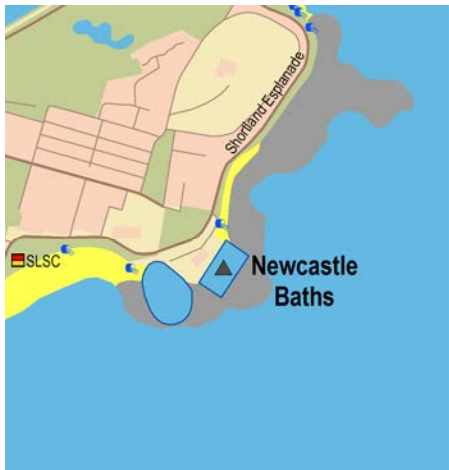
See 'How to read this report' for key to map

Newcastle Ocean Baths are at the northern end of Newcastle Beach, next to Canoe Pool. Council inspectors patrol the pool from October to April. The baths are emptied, cleaned and filled weekly throughout the year.

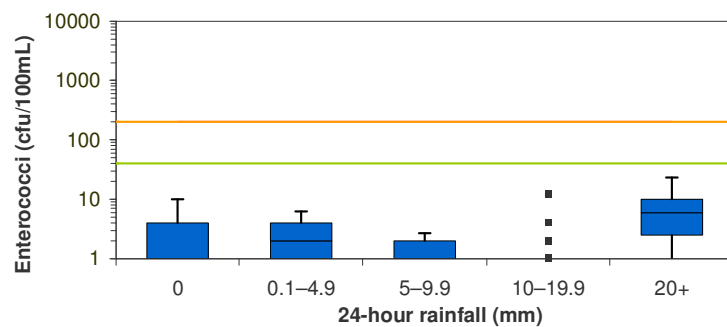
## Response to rainfall

The response to rainfall graph indicates that enterococci levels had little response to rainfall and remained below the safe swimming limit across all rainfall categories.

Rainfall from Nobbys (Newcastle) rain gauge

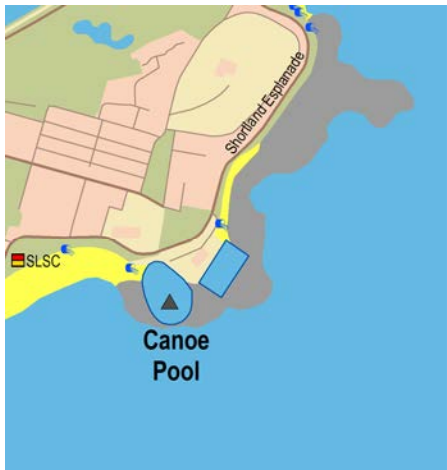
See 'How to read this report' for key to map

Canoe Pool is on the rock platform at the northern end of Newcastle Beach, next to Newcastle Ocean Baths. Lifeguards patrol the pool from October until April. The pool is emptied, cleaned and refilled each week during the summer season.

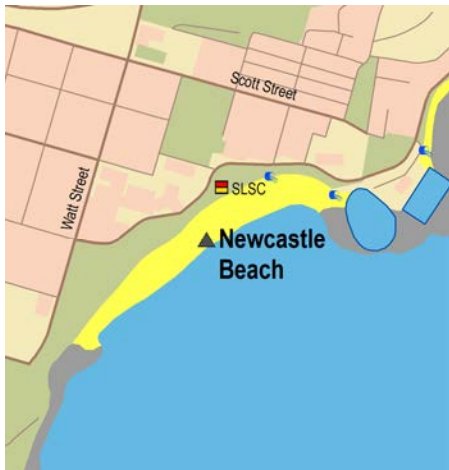
Newcastle Beach is approximately 650 metres long. Swimming can be dangerous as there are three permanent rips along the length of the beach. Lifeguards patrol the beach all year round.

See 'How to read this report' for key to map

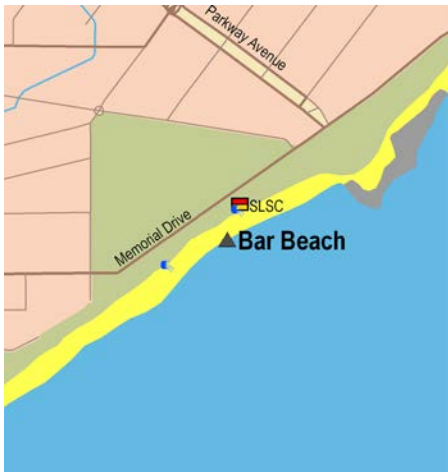
Bar Beach is approximately 500 metres long and is bordered by rock platforms. Conditions can be hazardous, as it is an open beach with numerous rips. Lifeguards patrol the beach all year round.

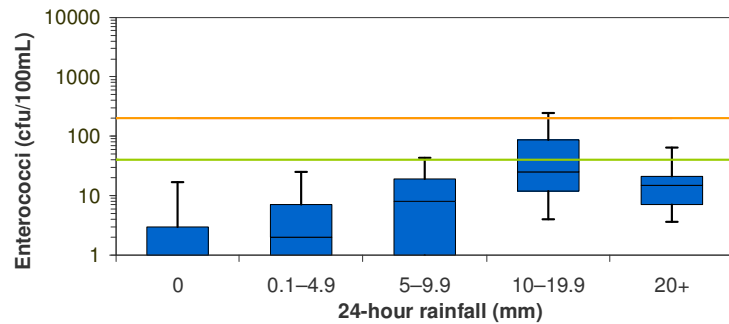
## Response to rainfall

The response to rainfall graph indicates that enterococci levels increased slightly with increasing rainfall, often exceeding the safe swimming limit after 10 mm or more of rainfall.

Rainfall from Nobbys (Newcastle) rain gauge

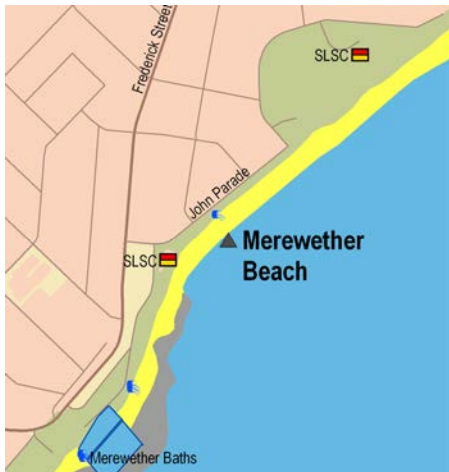
Merewether Beach is at the southern end of a 900 metre stretch of beach that extends north to Dixon Park Beach. There are two ocean pools on the southern rock platform. The beach is patrolled year round.

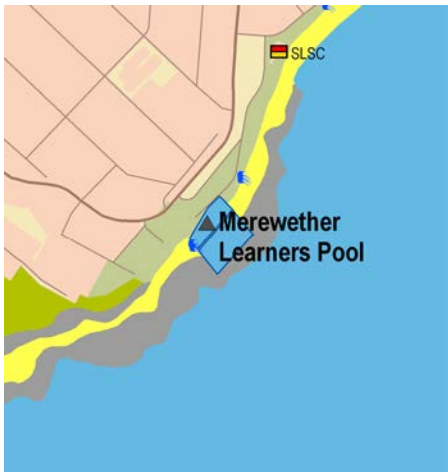
See 'How to read this report' for key to map

Merewether Learners Pool is at the southern end of Merewether Beach, adjoining Merewether Main Pool. Council inspectors patrol the pool from October to April. The baths are emptied, cleaned and refilled on a weekly basis throughout the whole year.

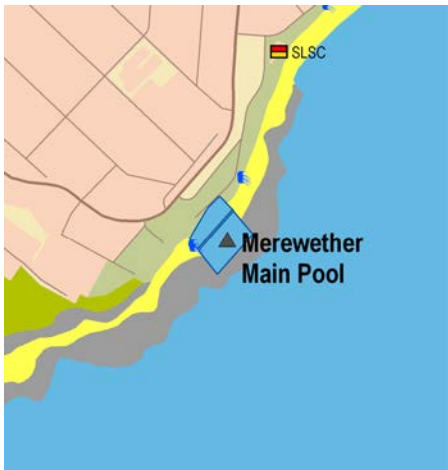
See 'How to read this report' for key to map

Merewether Main Pool is at the southern end of Merewether Beach, next to Merewether Learners Pool. Council inspectors patrol the pool from October to April. The baths are emptied, cleaned and refilled twice weekly throughout the bathing season, and on a weekly basis for the remainder of the year.

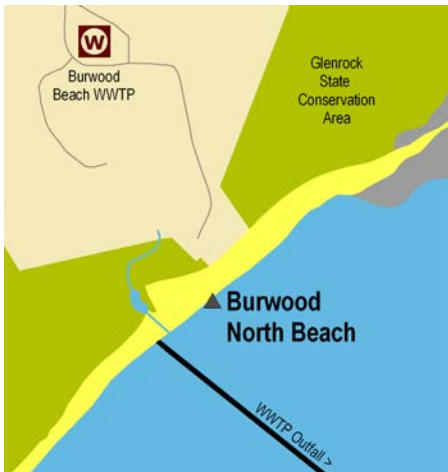
See 'How to read this report' for key to map

Burwood North Beach is toward the northern end of an 800 metre stretch of beach. It is backed by Glenrock State Conservation Area and Burwood Beach Wastewater Treatment Plant.

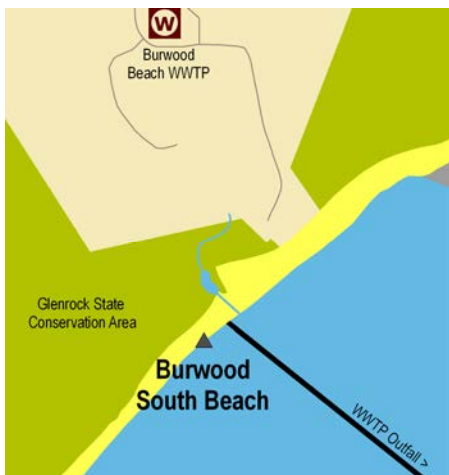
See 'How to read this report' for key to map

Burwood South Beach is located towards the southern end of an 800 metre stretch of beach. It is backed by Glenrock State Conservation Area and Burwood Beach Wastewater Treatment Plant.
