# Bega Park Playground Concept plan 2

Scale: 1:200 at A1  
Job No: 1411  
Date: MARCH 2015  
Dwg No: CP-02

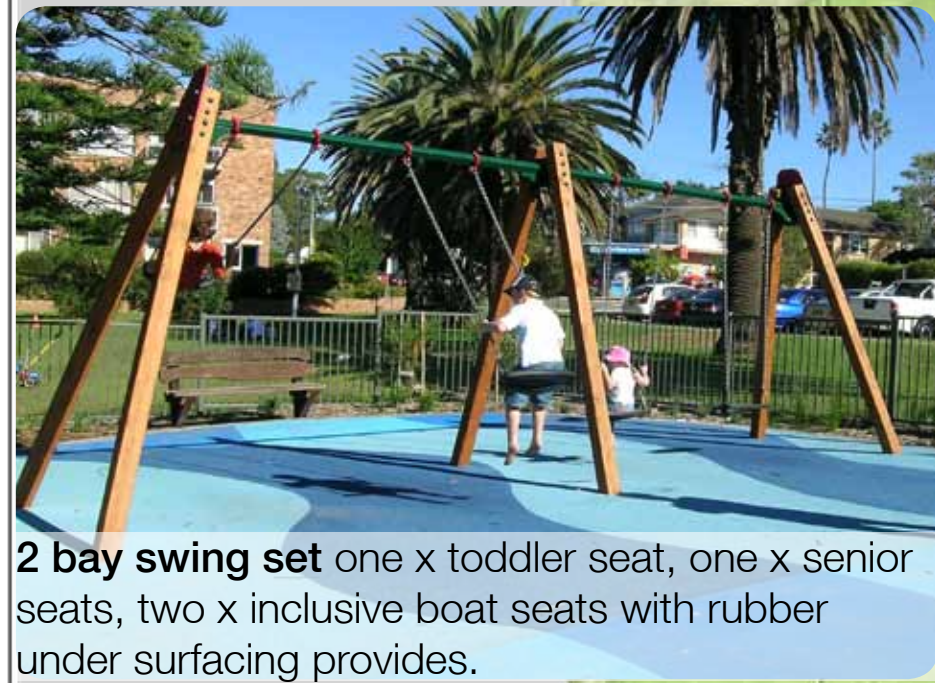
**2 bay swing set** one x toddler seat, one x senior seats, two x inclusive boat seats with rubber under surfacing provides.

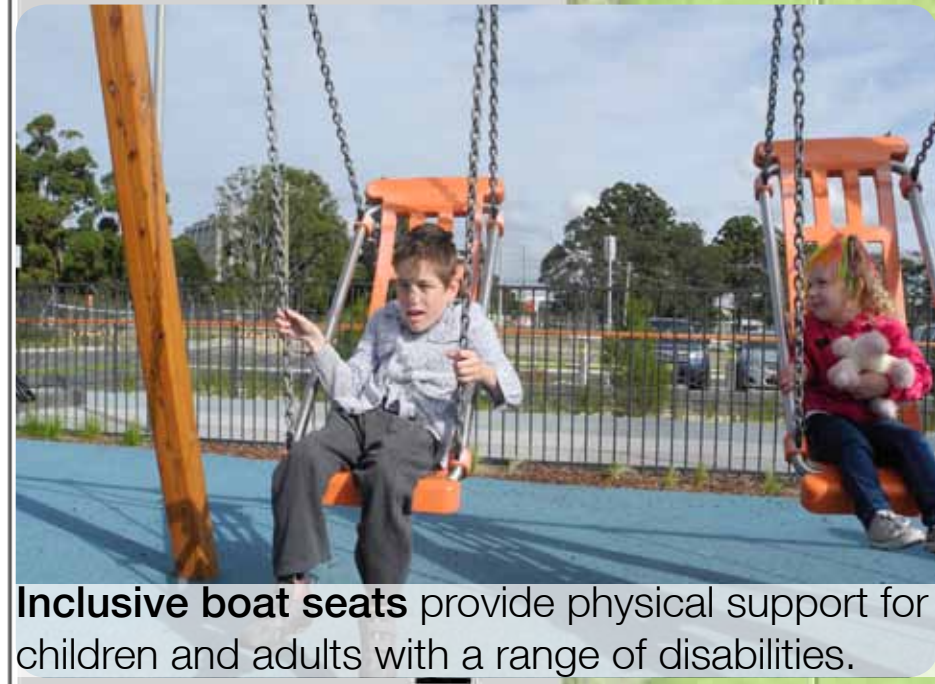
**Inclusive boat seats** provide physical support for children and adults with a range of disabilities.

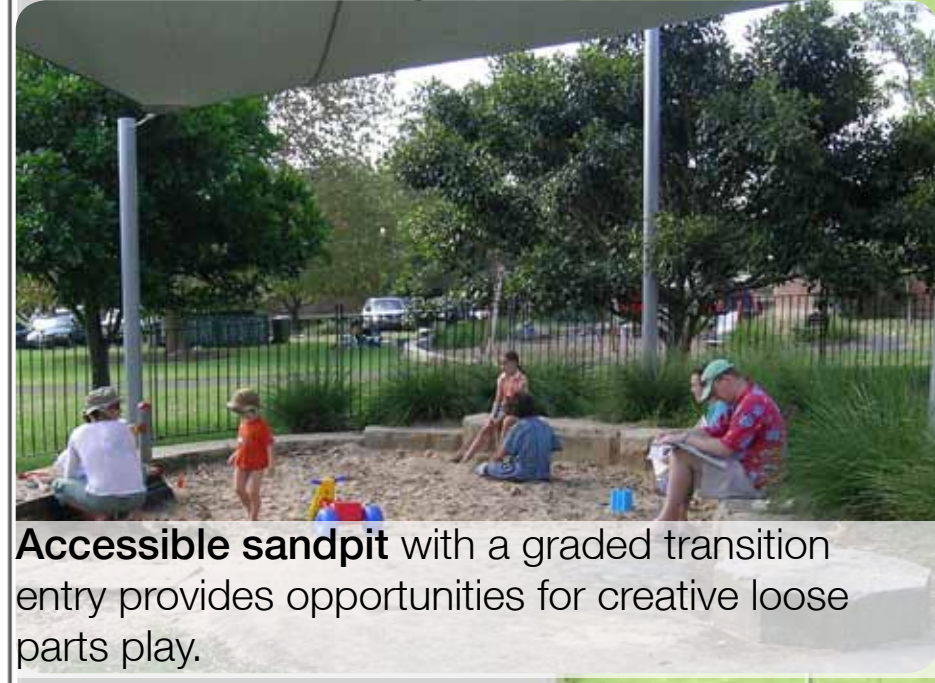
**Accessible sandpit** with a graded transition entry provides opportunities for creative loose parts play.

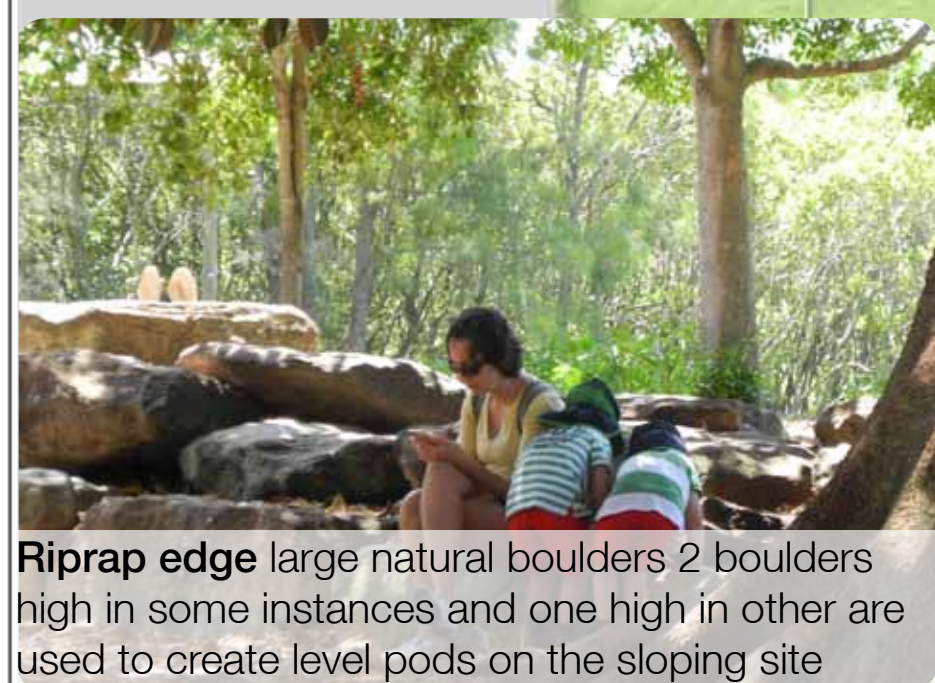
**Riprap edge** large natural boulders 2 boulders high in some instances and one high in other are used to create level pods on the sloping site

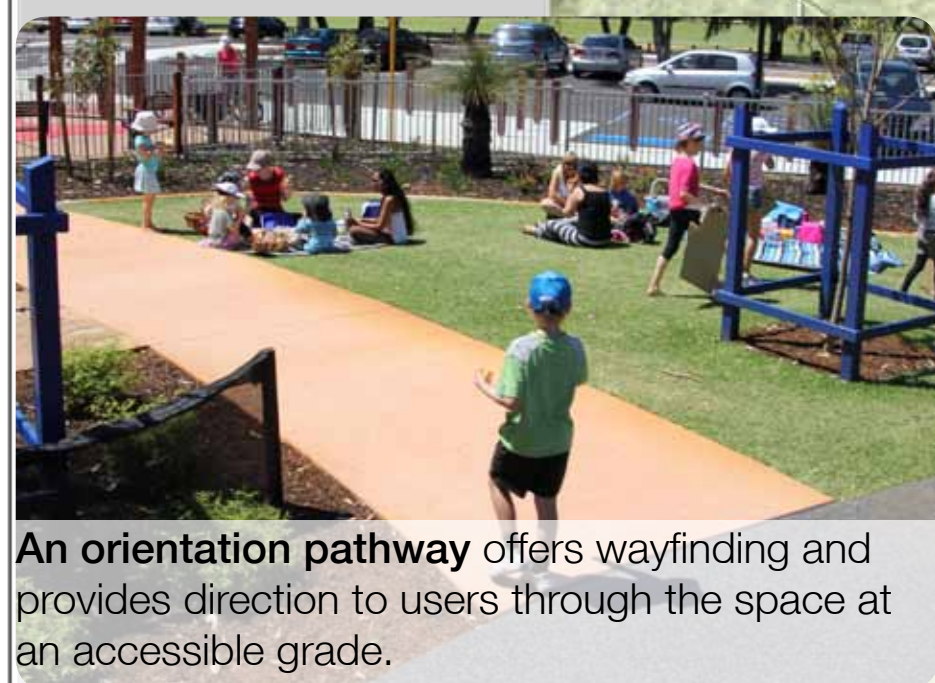
**An orientation pathway** offers wayfinding and provides direction to users through the space at an accessible grade.

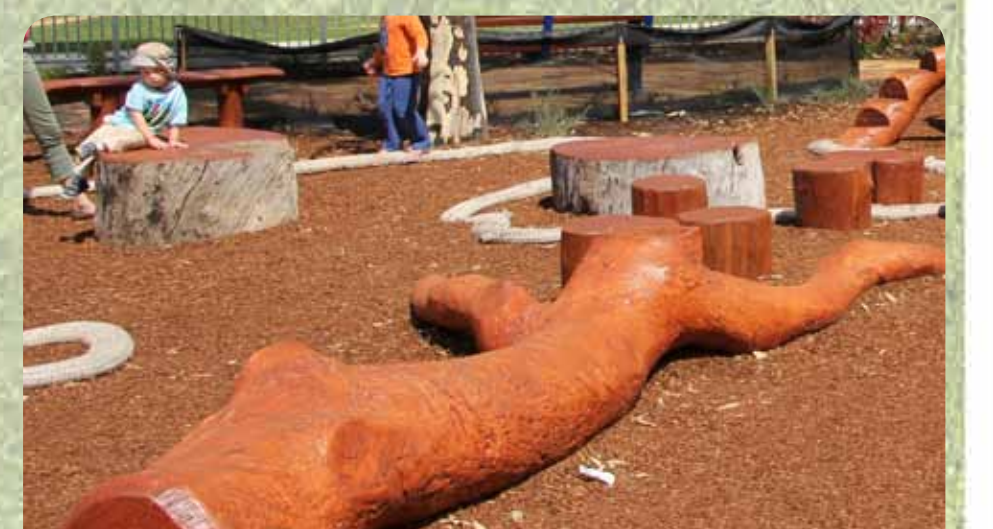
**Graduated balancing challenge** that gets incrementally harder over its length. Grade one hardwood.

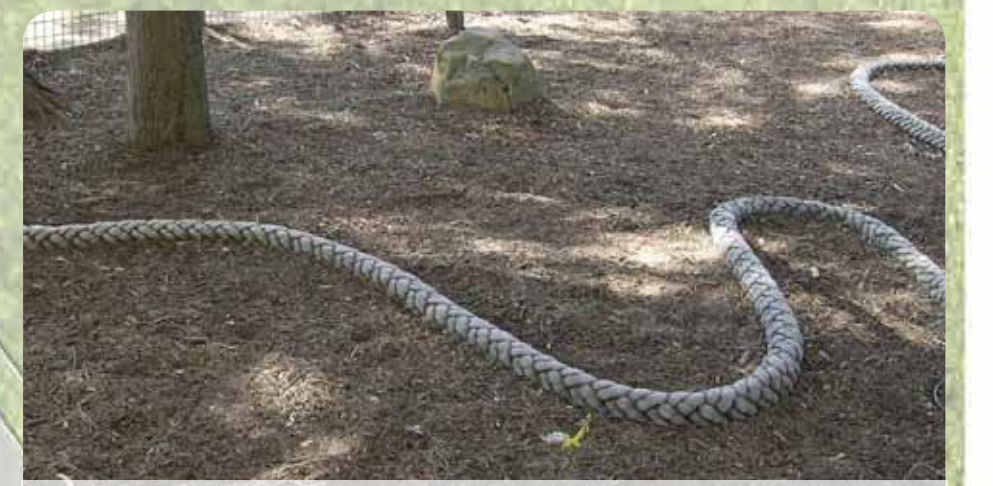
**Shipping ropes** can be static or dynamic and offer an easier and more accessible balance challenge with a highly textured and visual appearance.
